# Fire Door Survey Report

Example Fire Door Survey Report  
10 Downing St, London SW1A 2AB, UK

Surveyed by Shane Keaney on 12 Sep 2022

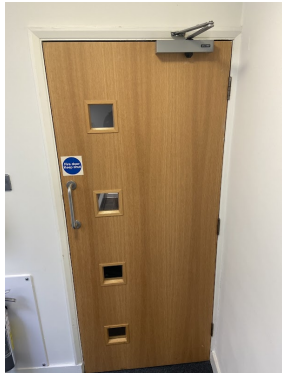
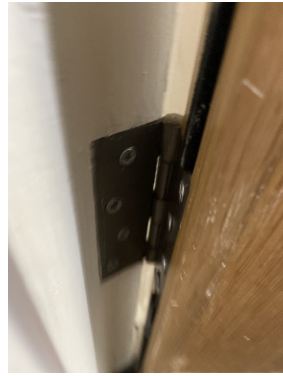
## [FD-001] Fifth floor

Door Item	Actions
<p>X-OVERALL. Overall status of the complete door set.</p> <p><b>Non Compliant</b></p> <p><i>Refit link shoe to frame</i></p>	<ul style="list-style-type: none"> <li>- <i>ADJUST. Pack hinges to equalise gaps x 1</i></li> <li>- <i>REPAIR. Repair door frame/leaf 30 mins</i></li> <li>- <i>REPLACE. Replace full set of worn defective hinges x 3</i></li> </ul>

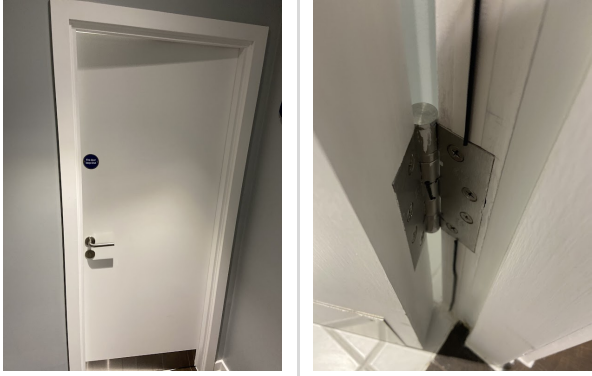
## [FD-003] Fifth floor

Door Description		Door Status	
Nominal Door		See Individual Door Items	
Door Item		Actions	
X-OVERALL. Overall status of the complete door set. Non Compliant		- <i>ADJUST. Pack hinges to equalise gaps x 1</i> - <i>INSTALL: Install furring piece to door x 1</i>

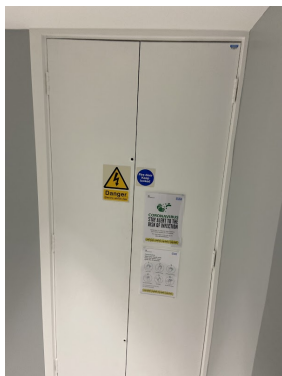
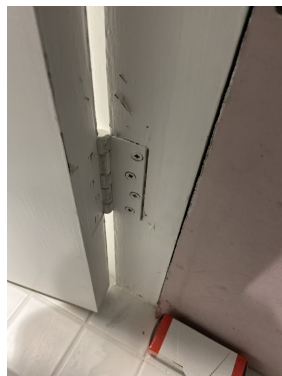
## [FD-004] Fifth floor

Door Item	Actions
<p>X-OVERALL. Overall status of the complete door set.</p> <p><b>Non Compliant</b></p> <p><i>No intumescent strips or smoke seals are fitted to door or frame</i></p>	<p>- <b>INSTALL:</b> <i>Install firing piece to door x 2</i></p> <p>- <b>REPLACE:</b> <i>Replace full set of worn defective hinges x 6</i></p> <p>- <b>REPLACE:</b> <i>Router new grooves to edge of door and replace combined smoke and intumescent seals x 2</i></p>

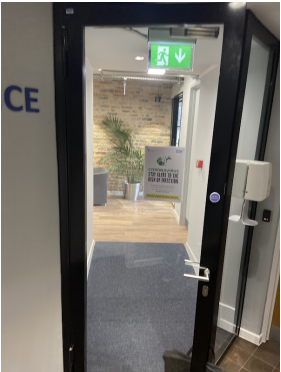
## [FD-002] Fifth floor

Door Item	Actions
<p>X-OVERALL. Overall status of the complete door set.</p> <p>Compliant</p> <p><i>Pyroguard (E) (I) integrity and insulation glass</i></p>	<p>No actions needed</p>

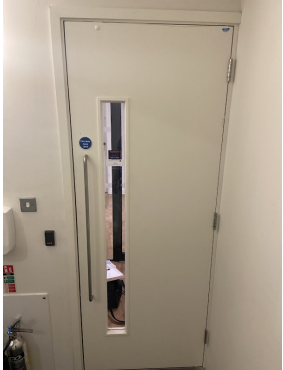
## [FD-006] Fourth floor

Door Item	Actions	
X-OVERALL. Overall status of the complete door set. Non Compliant	- <i>ADJUST. Pack hinges to equalise gaps x 1</i>

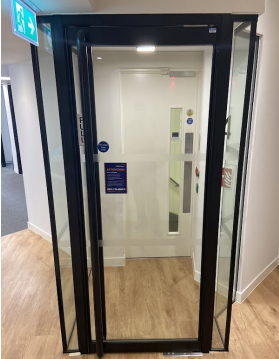
## [FD-007] Fourth floor

Door Item	Actions		
<p>X-OVERALL. Overall status of the complete door set.</p> <p><b>Non Compliant</b></p> <p><i>Promat pyrobel 15mm EN14449 laminated fire rated glass</i></p> <p><i>Handle is loose</i></p>	<p>- <i>ADJUST. Adjust and lubricate lock</i></p>

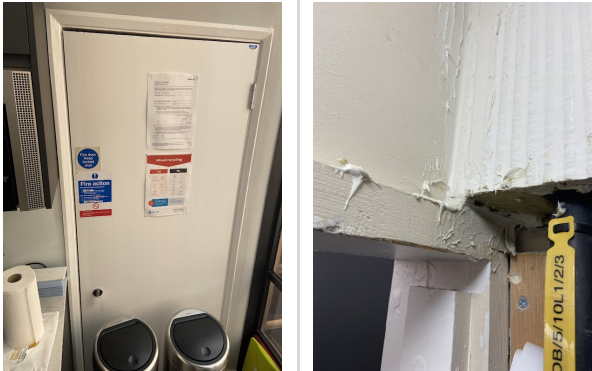
## [FD-005] Fifth floor

Door Item	Actions
<p>X-OVERALL. Overall status of the complete door set.</p> <p><b>Needs Complete Replacement</b></p> <p><i>Non compliant 28mm frame section, no intumescent strips or smoke seals fitted to door or frame, only 2 hinges fitted,</i></p>	<p><i>- PROOF. Client to confirm FR /FD 30 Nominal</i></p>

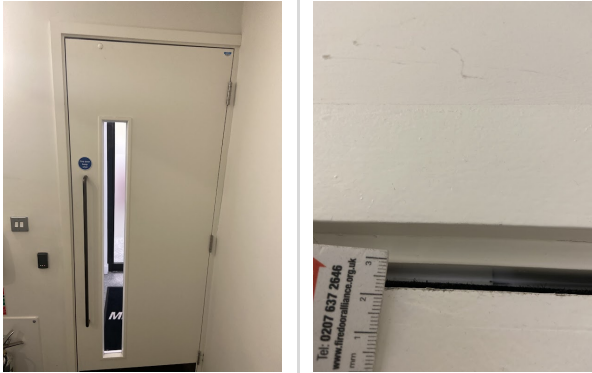
## [FD-010] Third floor

Door Item	Actions
<p>X-OVERALL. Overall status of the complete door set.</p> <p><b>Non Compliant</b></p> <p><i>gap at top of door cannot be close with ease and adjust, refit frame</i></p>	<p>- <b>ADJUST.</b> Remove single door and frame adjust and refit</p> <p>- <b>PROOF.</b> Client to confirm FR /FD 30 Nominal</p>

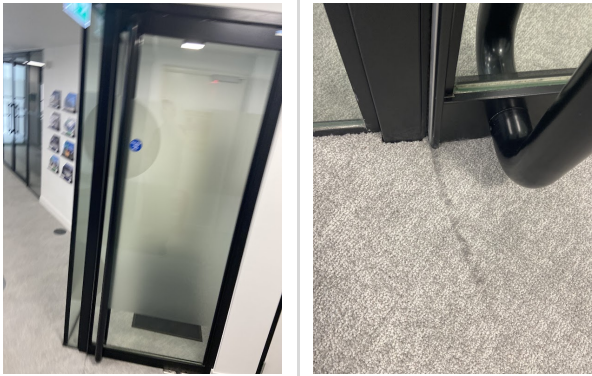
## [FD-011] Third floor

Door Item	Actions
<p>X-OVERALL. Overall status of the complete door set.</p> <p><b>Non Compliant</b></p> <p><i>Promat pyrobel 15mm EN14449 laminated fire glass</i>  <i>Door binds on floor and does not close to door jamb</i></p>	<p>- <i>ADJUST. Pack hinges to equalise gaps x 1</i></p> <p>- <i>ADJUST. Adjust closer power setting x 1</i></p>

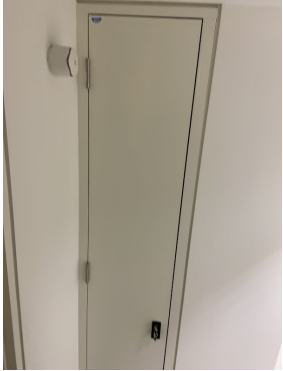
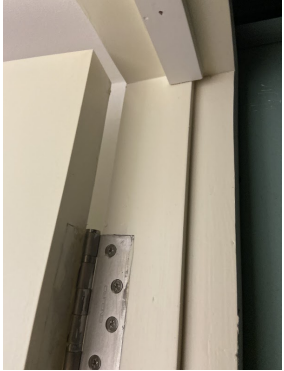
## [FD-012] Third floor

Door Description	Door Status	
Nominal Door	See Individual Door Items	
Door Item	Actions	
<p>X-OVERALL. Overall status of the complete door set.</p> <p><b>Non Compliant</b></p> <p><i>No intumescent strips or smoke seals are fitted to door or frame</i></p> <p><i>Door stop partially missing</i></p>	<ul style="list-style-type: none"> <li>- <b>REPAIR.</b> <i>Repair door frame/leaf 1 hour</i></li> <li>- <b>REPLACE.</b> <i>Router new grooves to edge of door and replace combined smoke and intumescent seals x 1</i></li> <li>- <b>INSTALL.</b> <i>Supply and fit correct door sign x 1</i></li> <li>- <b>PROOF.</b> <i>Client to confirm FR /FD 30 Nominal</i></li> </ul>

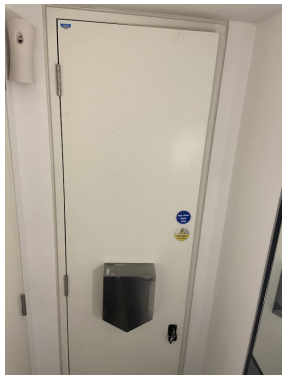
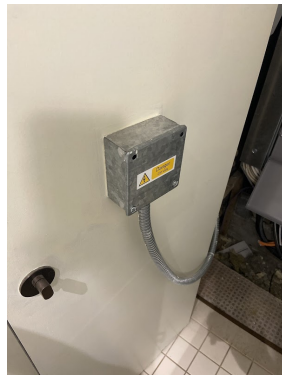
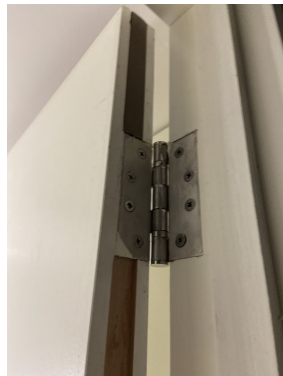
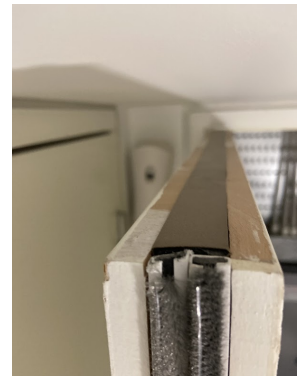
## [FD-013] Third floor

Door Item	Actions
<p>X-OVERALL. Overall status of the complete door set.</p> <p><b>Needs Complete Replacement</b></p> <p><i>Hand dryer is attached to door, client is to confirm with door manufacturer this is compliant. Could not see how big hole in door is and have advised a replacement, if hole is under 20mm in diameter the door could be repaired. Advice is to replace compromised door set and find alternative place for hand dryer on a wall 20mm Fire seals are partially missing on stile, client to confirm this is a Fire door only, however, smoke seals are fitted to latch stile only. new signage needed fit FDKL to front of door</i></p>	<p>- <b>PROOF. Client to confirm FR /FD 30 Nominal</b></p>

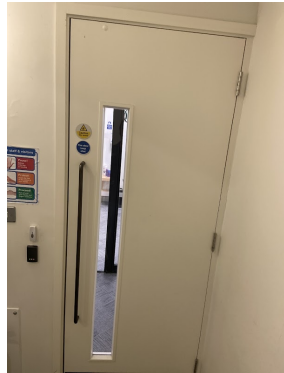
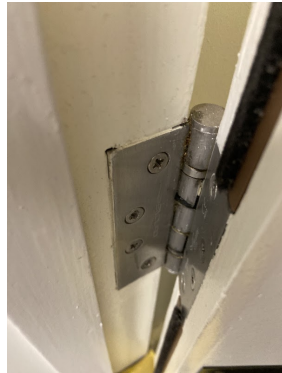
## [FD-014] Second floor

Door Item	Actions
<p>X-OVERALL. Overall status of the complete door set.</p> <p><b>Non Compliant</b></p>	<p>- <i>ADJUST. Pack hinges to equalise gaps x 1</i></p> <p>- <i>PROOF. Client to confirm FR /FD 30 Nominal</i></p>

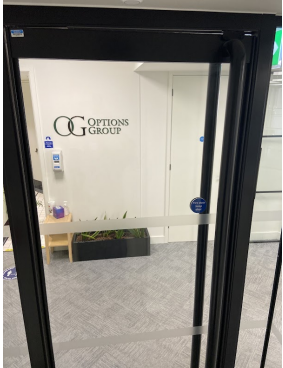
## [FD-015] Second floor

Door Item	Actions
<p>X-OVERALL. Overall status of the complete door set.</p> <p><b>Non Compliant</b></p> <p><i>Promat Pyrobel 15mm EN14449 laminated fire glass</i>  <i>Door binds on frame and needs adjustment</i></p>	<p>- <i>ADJUST. Pack hinges to equalise gaps x 1</i></p> <p>- <i>ADJUST. Adjust closer power setting x 1</i></p>

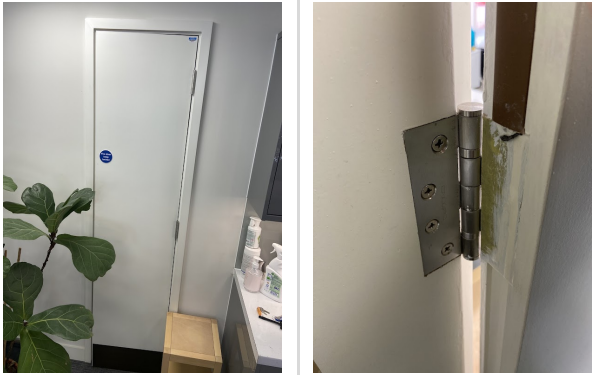
## [FD-016] Second floor

Door Item	Actions
<p>X-OVERALL. Overall status of the complete door set.</p> <p><b>Non Compliant</b></p> <p><i>Fire door only, no smoke seals fitted to door, client to confirm if this is correct</i></p> <p><i>20mm fire seal brown</i></p>	<p>- <b>ADJUST.</b> Pack hinges to equalise gaps x 1</p> <p>- <b>REPLACE.</b> Replace fire seals into existing grooves x 1</p>

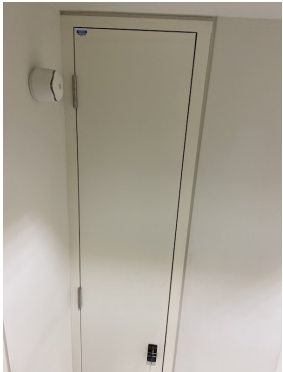
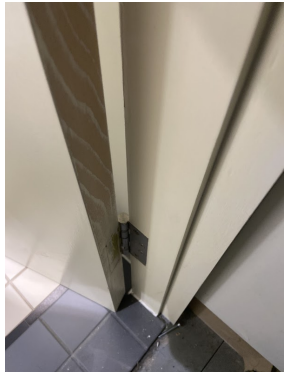
## [FD-017] Second floor

Door Description	Door Status	
Nominal Door	See Individual Door Items	
Door Item	Actions	
<p>X-OVERALL. Overall status of the complete door set.</p> <p><b>Non Compliant</b></p> <p><i>No intumescent strips or smoke seals are fitted to door or frame</i></p>	<p>- <b>INSTALL.</b> <i>Supply and fit correct door sign x 1</i></p> <p>- <b>REPLACE.</b> <i>Router new grooves to edge of door and replace combined smoke and intumescent seals x 1</i></p>

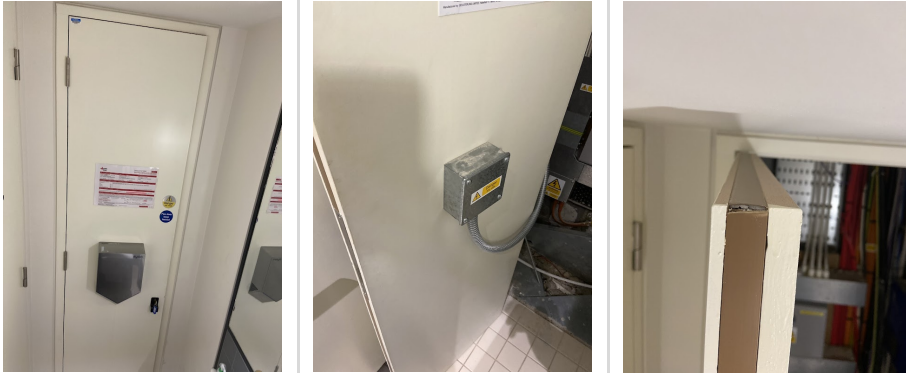
## [FD-018] Second floor

Door Item	Actions
<p>X-OVERALL. Overall status of the complete door set.</p> <p><b>Needs Complete Replacement</b></p> <p><i>Hand dryer is attached to door, client is to confirm with door manufacturer this is compliant, Could not see how big hole in door is and have advised a replacement, if hole is under 20mm in diameter the door could be repaired.</i></p> <p><i>Advice is to replace compromised door set and find alternative place for hand dryer on a wall</i></p> <p><i>20mm Fire seals fitted no smoke seals on door or frame, client to confirm this is a fire door only.</i></p>	<p>No actions needed</p>

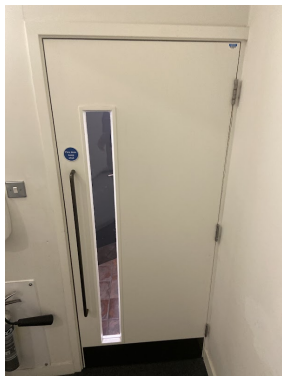
## [FD-020] First floor

Door Item	Actions
X-OVERALL. Overall status of the complete door set. <b>Non Compliant</b>	- <i>ADJUST. Pack hinges to equalise gaps x 1</i> - <i>PROOF. Client to confirm FR /FD 30 Nominal</i>

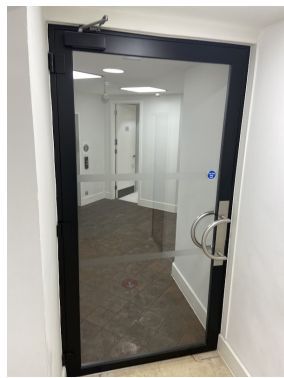
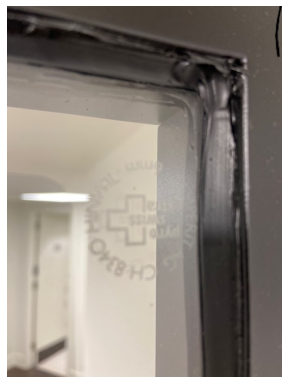
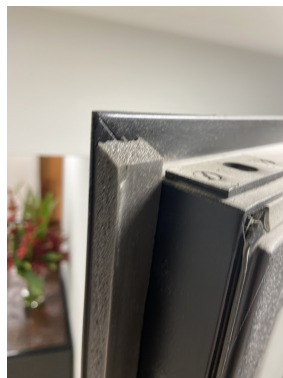
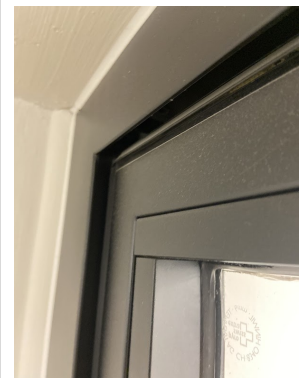
## [FD-021] First floor

Door Item	Actions
<p>X-OVERALL. Overall status of the complete door set.</p> <p><b>Non Compliant</b></p> <p><i>Foam is attached to latch stile to stop door from banging against the frame, this foam is stopping the door closing to door jamb and engaging in latched position, a solution could be to adjust closer and back check if fitted with a back check, or fit slimmer foam material or neoprene rubber to stile to allow door to close effectively.</i></p> <p><i>Pyroswiss extra CH8340 6mm glass, fire resistant glass</i></p>	<p>- <b>REPAIR. Repair door frame/leaf 1 hour</b></p>

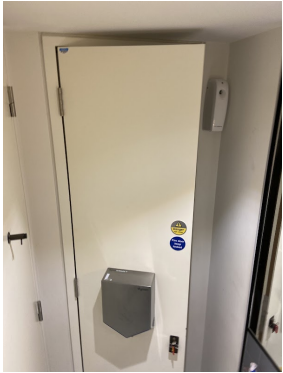
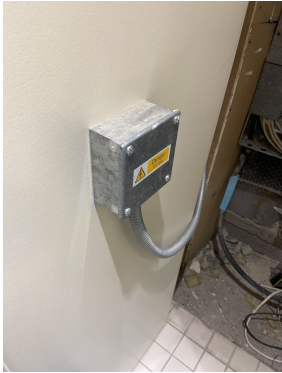
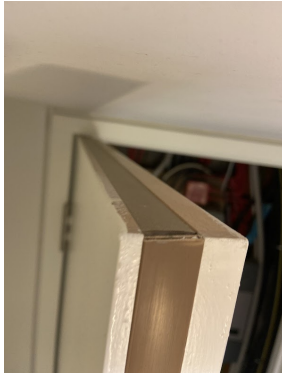
## [FD-023] First floor

Door Item	Actions
<p>X-OVERALL. Overall status of the complete door set.</p> <p><b>Needs Complete Replacement</b></p> <p><i>Hand dryer is attached to door, client is to confirm with door manufacturer this is compliant, Could not see how big hole in door is and have advised a replacement, if hole is under 20mm in diameter the door could be repaired.</i></p> <p><i>Advice is to replace compromised door set and find alternative place for hand dryer on a wall</i></p> <p><i>20mm Fire seals fitted, no smoke seals to door or frame, client to confirm if this is correct</i></p>	<p>No actions needed</p>

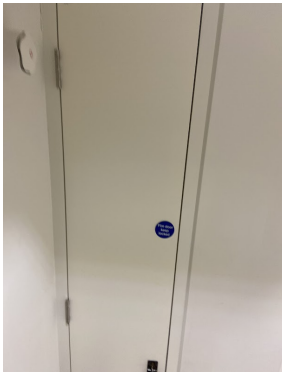
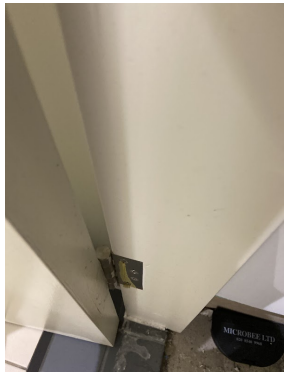
## [FD-022] First floor

Door Description	Door Status	
Nominal Door	See Individual Door Items	
Door Item	Actions	
<p>X-OVERALL. Overall status of the complete door set.</p> <p><b>Non Compliant</b></p> <p><i>No intumescent strips or smoke seals fitted to door or frame</i></p> <p><i>Door stop is partially missing</i></p>	<p><i>- REPLACE. Router new grooves to edge of door and replace combined smoke and intumescent seals x 1</i></p> <p><i>- ADJUST. Pack hinges to equalise gaps x 1</i></p> <p><i>- INSTALL: Install furring piece to door x 1</i></p>

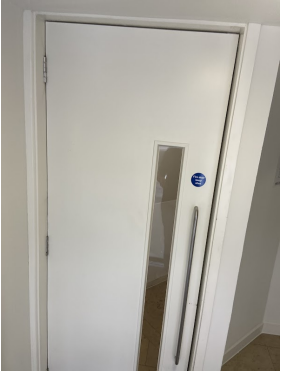
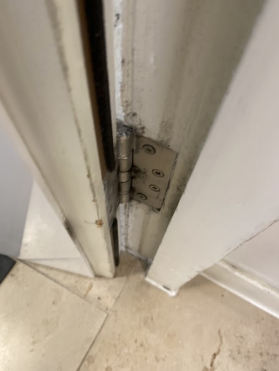
## [FD-024] Ground floor

Door Description	Door Status	
Nominal Door	See Individual Door Items	
Door Item	Actions	
X-OVERALL. Overall status of the complete door set. Non Compliant	- <i>ADJUST. Pack hinges to equalise gaps x 1</i>

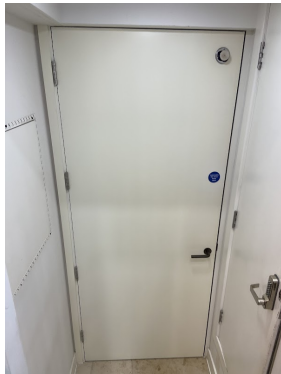
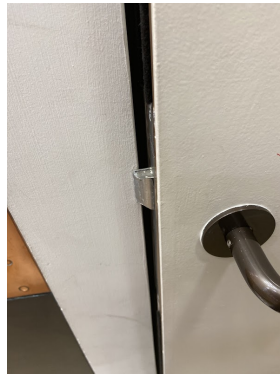
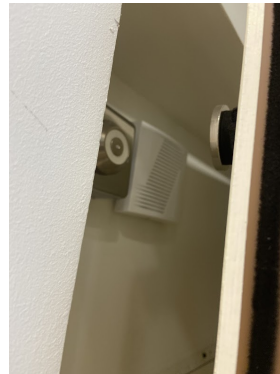
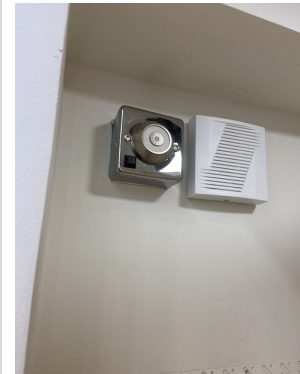
## [FD-026] Basement

Door Item	Actions
<p>X-OVERALL. Overall status of the complete door set.</p> <p><b>Non Compliant</b></p> <p><i>Hold open device will not operate as door latch binds against the supporting wall, magnetic wall device will need to be mounted on a piece of timber so as both magnets touch and hold door open and release. unable to see how much the device will need to be brought forward, maybe 50mm.</i></p> <p><i>Door does not close to latched position, may have to reposition door as door leaf binds on frame</i></p>	<ul style="list-style-type: none"> <li>- <b>ADJUST.</b> Pack hinges to equalise gaps x 1</li> <li>- <b>ADJUST.</b> Remove single door and frame adjust and refit</li> <li>- <b>REPAIR.</b> Repair door frame/leaf 1.5 hours</li> <li>- <b>PROOF.</b> Client to confirm FR /FD 30 Nominal</li> </ul>

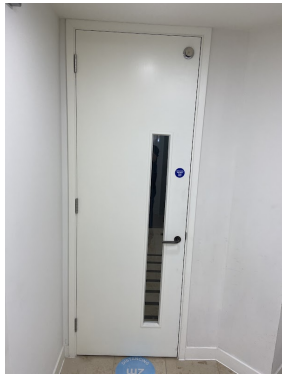
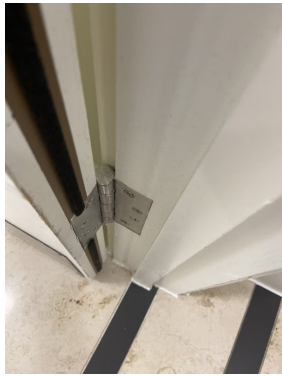
## [FD-027] Basement

Door Item	Actions
<p>X-OVERALL. Overall status of the complete door set.</p> <p><b>Non Compliant</b></p> <p><i>Door does not close to latched position</i></p>	<ul style="list-style-type: none"> <li>- <i>ADJUST. Pack hinges to equalise gaps x 1</i></li> <li>- <i>INSTALL: Install furring piece to door x 1</i></li> <li>- <i>PROOF. Client to confirm FR /FD 30 Nominal</i></li> </ul>

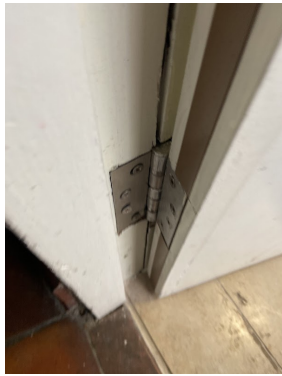
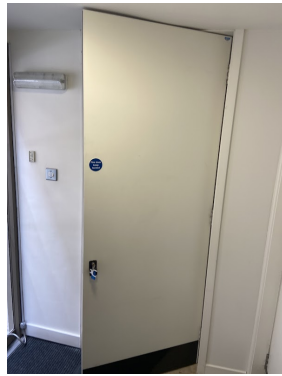
## [FD-025] Ground floor

Door Item	Actions
<p>X-OVERALL. Overall status of the complete door set.</p> <p><b>Non Compliant</b></p> <p><i>Fire door only client to confirm if this is correct</i></p>	<p>- <b>ADJUST. Pack hinges to equalise gaps x 1</b></p> <p>- <b>PROOF. Client to confirm FR /FD 30 Nominal</b></p>

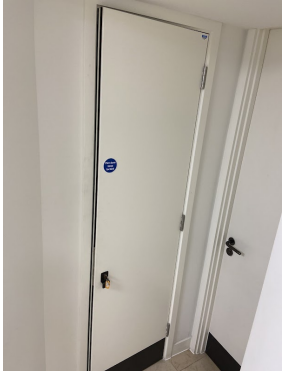
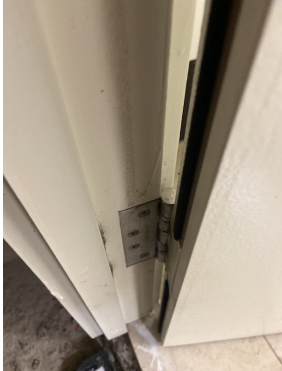
## [FD-028] Basement

Door Description	Door Status	
Nominal Door	See Individual Door Items	
Door Item	Actions	
<p>X-OVERALL. Overall status of the complete door set.</p> <p><b>Non Compliant</b></p>	<p>- <i>INSTALL: Install firing piece to door x 1</i></p> <p>- <i>PROOF. Client to confirm FR /FD 30 Nominal</i></p>

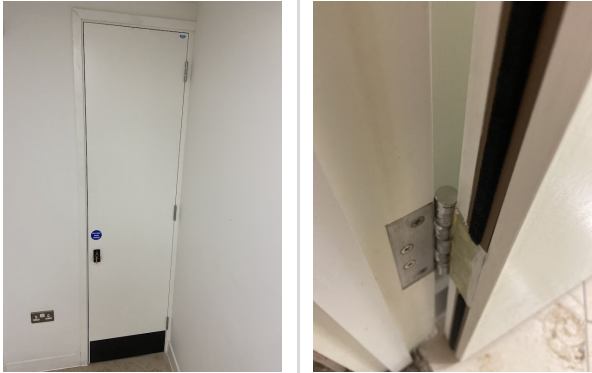
## [FD-029] Basement

Door Description		Door Status	
Nominal Door		See Individual Door Items	
Door Item		Actions	
GAPS Non Compliant		- <i>ADJUST. Pack hinges to equalise gaps x 1</i> - <i>INSTALL: Install furring piece to door x 1</i> - <i>PROOF. Client to confirm FR /FD 30 Nominal</i>

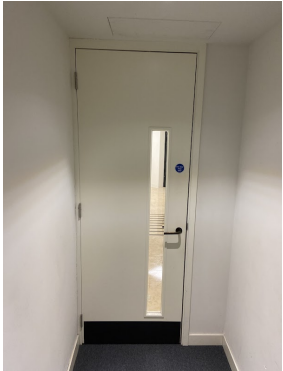
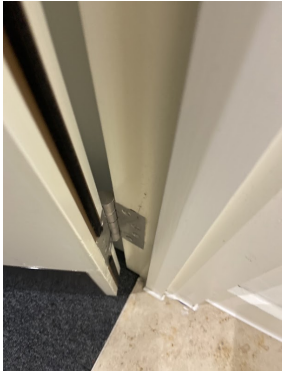
## [FD-030] Basement

Door Description	Door Status	
Nominal Door	See Individual Door Items	
Door Item	Actions	
<p>X-OVERALL. Overall status of the complete door set.</p> <p><b>Non Compliant</b></p>	<p>- <i>ADJUST. Pack hinges to equalise gaps x 1</i></p> <p>- <i>INSTALL: Install furring piece to door x 1</i></p> <p>- <i>PROOF. Client to confirm FR /FD 30 Nominal</i></p>

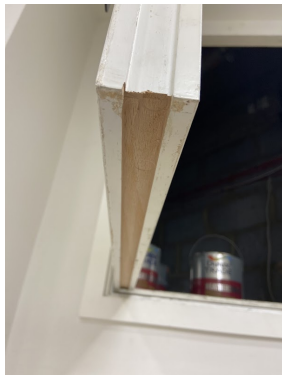
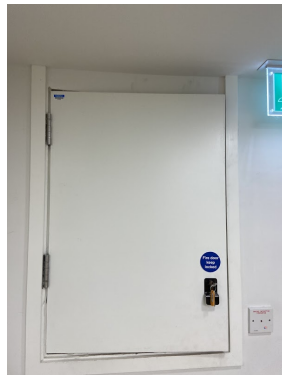
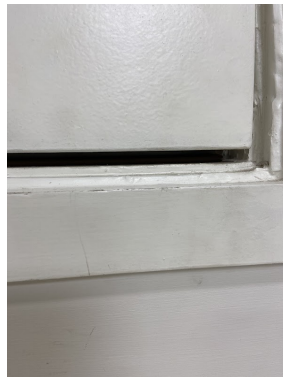
## [FD-032] Basement

Door Item	Actions
<p>X-OVERALL. Overall status of the complete door set.</p> <p><b>Non Compliant</b></p> <p><i>Fire door only no smoke seals fitted, client to confirm</i></p> <p><i>Fire seal needs reattaching to door and is partially missing from latch stile</i></p> <p><i>20mm brown</i></p> <p><i>Add lipping to close gap at bottom, may have to lip frame</i></p> <p><i>poorly fitted door set</i></p>	<ul style="list-style-type: none"> <li>- <b>ADJUST.</b> Pack hinges to equalise gaps x 1</li> <li>- <b>INSTALL:</b> Install furring piece to door x 1</li> <li>- <b>REPAIR.</b> Repair door frame/leaf 30 mins</li> <li>- <b>PROOF.</b> Client to confirm FR /FD 30 Nominal</li> </ul>

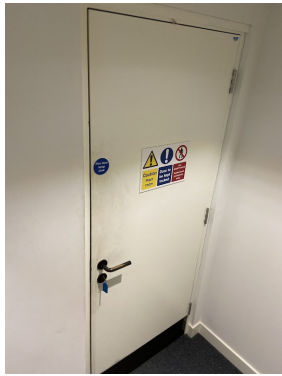
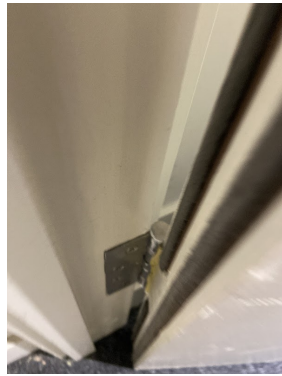
## [FD-031] Basement

Door Item	Actions
<p>X-OVERALL. Overall status of the complete door set.</p> <p><b>Non Compliant</b></p> <p><i>15mm combined smoke brush brown</i></p>	<p>- <b>REPLACE.</b> <i>Replace combined smoke and intumescent seals into existing grooves x 2</i></p> <p>- <b>ADJUST.</b> <i>Pack hinges to equalise gaps x 1</i></p>

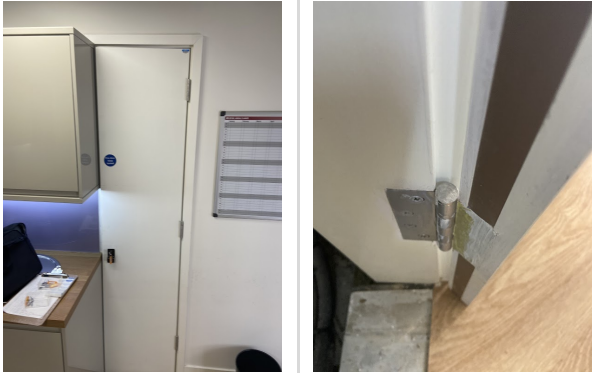
## [FD-008] Fourth floor

Door Item	Actions
<p>X-OVERALL. Overall status of the complete door set.</p> <p><b>Non Compliant</b></p> <p><i>Fire door only, no smoke seals are fitted to door or frame client to confirm</i></p>	<p><i>- ADJUST. Remove single door and frame adjust and refit</i></p>

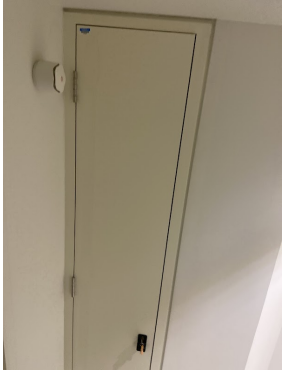
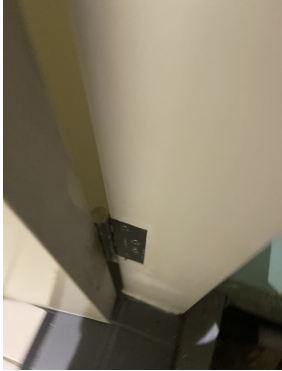
## [FD-009] Fourth floor

Door Description	Door Status	
Nominal Door	See Individual Door Items	
Door Item	Actions	
<p>SEALS COMBINED SMOKE &amp; FIRE</p> <p><b>Non Compliant</b></p> <p><i>No intumescent strips or smoke seals are fitted to door or frame</i></p> <p><i>Door stop partially missing</i></p>	<ul style="list-style-type: none"> <li>- <i>REPLACE. Router new grooves to edge of door and replace combined smoke and intumescent seals x 1</i></li> <li>- <i>REPAIR. Repair door frame/leaf 30 mins</i></li> <li>- <i>INSTALL. Supply and fit correct door sign x 1</i></li> <li>- <i>PROOF. Client to confirm FR /FD 30 Nominal</i></li> </ul>

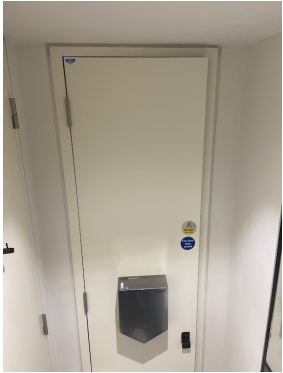
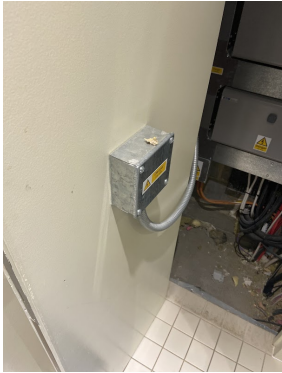
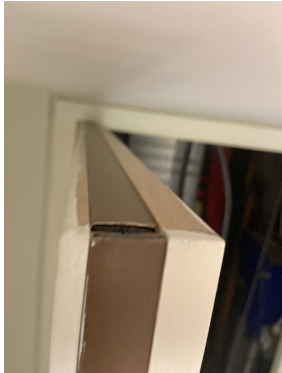
## [FD-019] Fourth floor

Door Item	Actions
<p>X-OVERALL. Overall status of the complete door set.</p> <p><b>Non Compliant</b></p> <p><i>Hand dryer is attached to door, client is to confirm with door manufacturer this is compliant, Could not see how big hole in door is and have advised a replacement, if hole is under 20mm in diameter the door could be repaired. Advice is to replace compromised door set and find alternative place for hand dryer on a wall Fire door only. No smoke seals fitted to door or frame, client to confirm if this is correct</i></p>	<p>- <b>PROOF. Client to confirm FR /FD 30 Nominal</b></p>

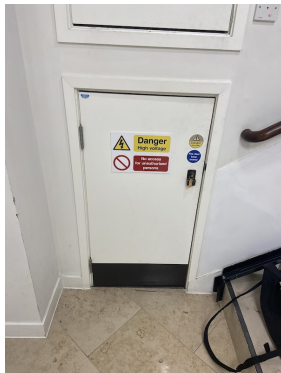
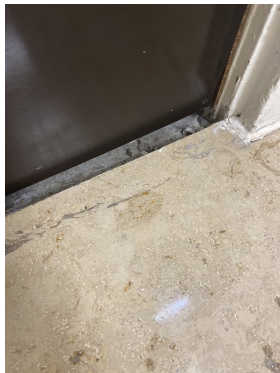
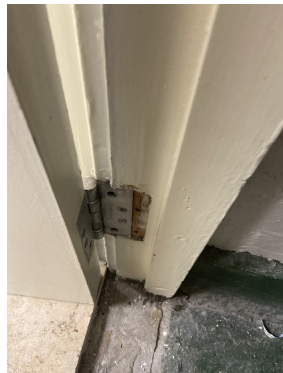
## [FD-033] Basement

Door Item	Actions
<p>X-OVERALL. Overall status of the complete door set.</p> <p><b>Non Compliant</b></p> <p><i>Floor will need to be levelled with concrete as there is a large gap under door when in latched position, smoke and fire could compromise this door set via the threshold.</i></p> <p><i>Reattach loose combined smoke seal to latch stile.</i></p> <p><i>Hinges are not set correctly in frame and gaps need patching, screws are missing, These doors may need to be replaced if they can not be remediated effectively.</i></p> <p><i>This is a poorly fitted door set along with the door set above</i></p>	<ul style="list-style-type: none"> <li>- <b>REPAIR.</b> <i>Repair door frame/leaf 1.5 hours</i></li> <li>- <b>REPAIR.</b> <i>Repair door frame/leaf 30 mins</i></li> <li>- <b>ADJUST.</b> <i>Pack hinges to equalise gaps x 1</i></li> <li>- <b>INSTALL.</b> <i>Raise door chop hinges x 1</i></li> <li>- <b>PROOF.</b> <i>Client to confirm FR /FD 30 Nominal</i></li> </ul>
